### Different technical modifications and updatings on coral 70s

# adiate Newsletter - 88

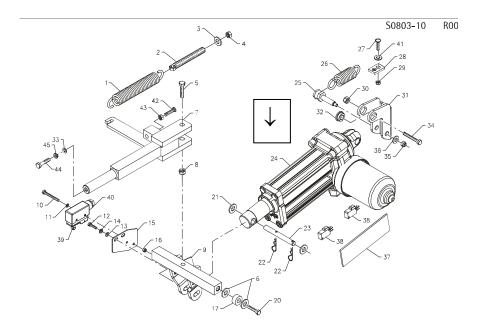
Ref. table S0803-10 R00 We have modified the drawing correcting mainly the design of the actuator.

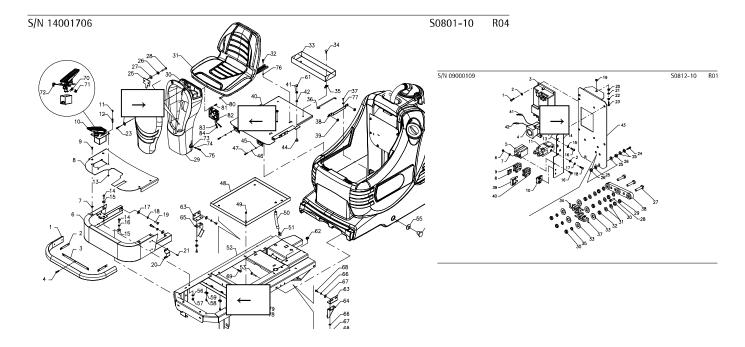
Starting from serial number: 14001706 dated 29/04/14 – table S0801–10 R04 and S0812–10 R01 To improve the performances of the chopper card, we have added a cooling fan. This device requires the realization of ventilation openings on the front column, on the front frame and on the electric panel. The modification can be applied also on already produced machines. The complete assembly of the fan has part number: V0812010

The assembling instructions with No. T081208 are available.

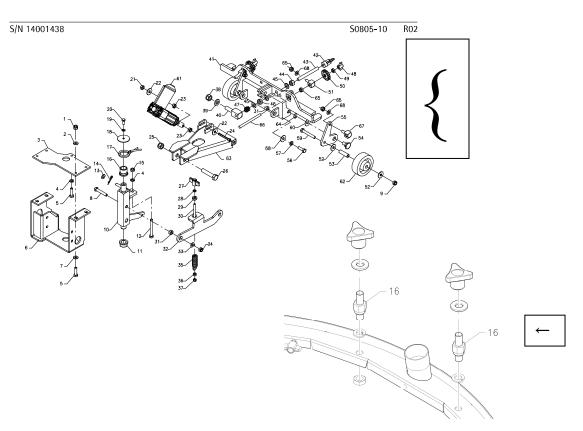
## → Starting from serial number: 14001438 dated 08/04/14 – table S0805-10 R02

The complete squeegee coupling is replaced with a new one, because the adjustment with this new system is much more solid also in presence of heavy impacts. Consequently the adjustment system has been modified and therefore a new coupling and new wheel supports are needed. The adjustment will not be anymore by simple leaning onto the support but the new system will be equipped with a threaded tie rod and adjuster. The new system may be applied integrally also on already produced machines being cautious to replace also the two stud bolts of the squeegee (ref. table S0804-10 R00, pos. 16, part No. 20604030).

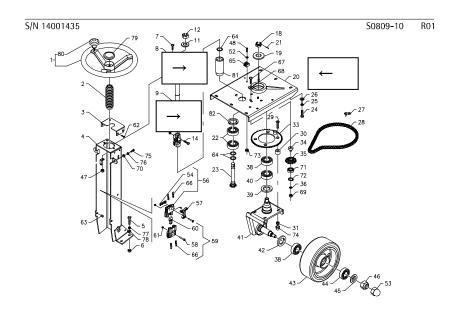
→ Starting from serial number: 14001435 – table S0809-10 R01

The bearing pipe of the steering wheel pinion becomes disassembled because welding it to the steering wheel support the seat of the lower bearing is often deformed. This application is already assembled on coral 65m. On the steering wheel support (pos. 20) the hole has been modified by increasing the diameter to 50,5mm and realizing an anti-rotation key. On the pipe (pos. 81) an M50 thread has been obtained with a grooved seat for the key. The fixing is obtained by screwing the ring nut M50 (pos. 82). In case of spare parts requests, we can supply in place of part number 20809040 (steering wheel support) the assembly made of:

pos. 20 20809060 steering wheel support

pos. 81 20809320 pipe bearings

pos. 82 60285010 blocking ring nut M50x1,5

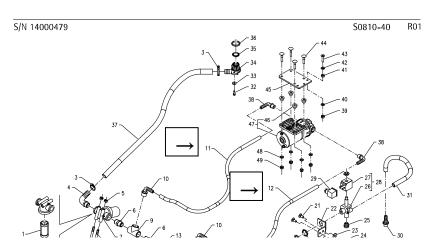
→ Starting from serial number: 14000479 dated 28/01/14 – table S0810-40 R01, pos. 11 and 12 To optimize the water course we have changed the hose circuits of the pump. This is valid only for the machines equipped with the dosing system.

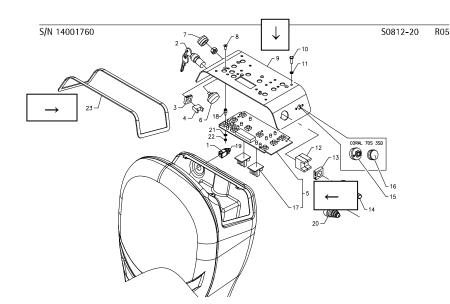
All the problems of the check card are given from interferences that the electric layout gives to the microprocessor.

We have intervened both in the hardware and in the software:

- hardware: we have added two filter condensers on the actuator modules that filter eventual interferences coming from the actuator motors.
- **software**: we have modified the starting ramps of the actuator motors. Having a slower start, the possible disturbances may be of lower intensity.

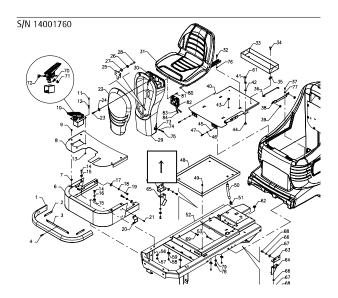
→ Starting from serial number: 14001760 dated 08/05/14, table S0812-20 R05 and table S0801-10 R05

The front covering and the control panel has been replaced to fit the sealing gasket. The housing of the control panel (pos. 9) has been enlarged to permit the assembly of a sealing gasket (pos. 23). The modification requires an intervention on the mould of the front covering 20611010 which cannot be supplied anymore as a spare part for the produced machines. In case of spare parts requests, it is necessary to supply the new front covering with the new control panel and the gasket, informing us about the colour of the covering. The label of the control panel remains unchanged.
