Technical modifications and updating of the spare parts catalogues suitable for our scrubbing machines at 230V

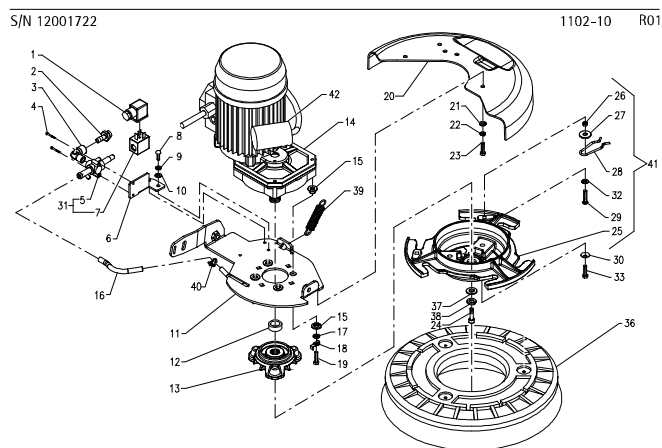
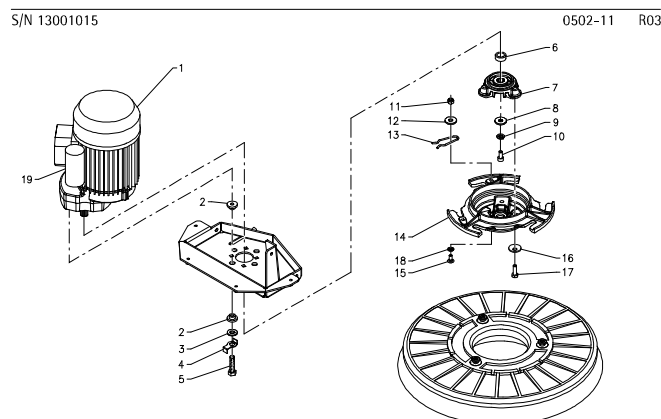
→ Starting from serial number: 12001722 dated 21/05/12 (**baby e**, table 1102-10 R01, pos. 18)
13001015 dated 15/03/13 (**ruby 50e**, table 0502-11 R03, pos. 4)

We have had some cases where, because of the vibrations, the screws that fix the geared motor to the brush base loosened themselves. We intervened replacing dowels and nuts with screws and by inserting safety washers between the screw heads and the brush base. With this modification it is not necessary anymore to block the screws with blocking glue.

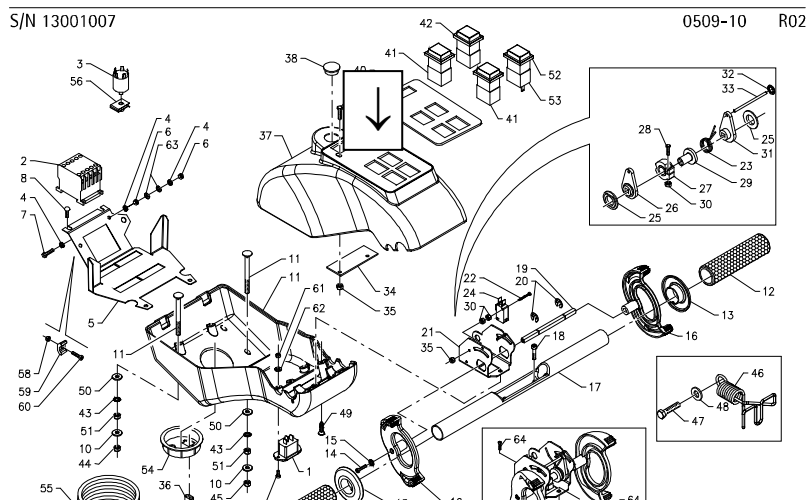
During some tests carried out we have verified that the label of the instrument board could get damaged near the two upper switch housings risking to enter in contact with electric parts. To avoid this problem we have realized a new cover having four holes instead of six ones. For spare parts the new cover can be sent in place of the previous one.

Take off: 49201020 handle bar cover

49201050 handle bar cover black

Add: 49205030 handle bar cover 4 holes

49205040 handle bar cover 4 holes black

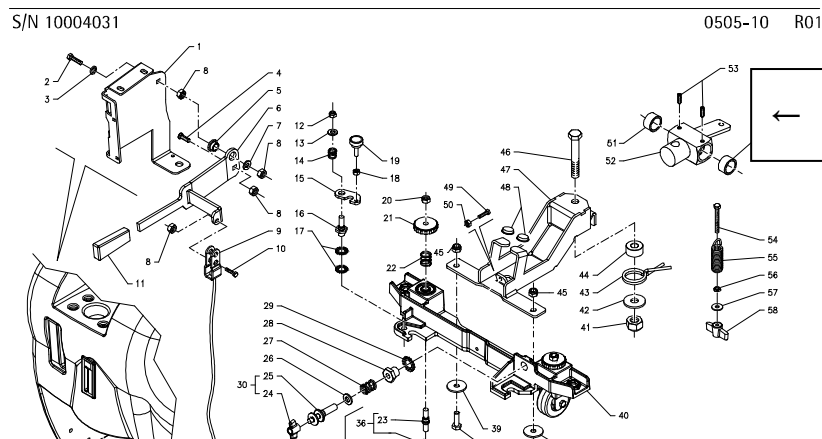
→ Starting from serial number: 13001004 dated 13/03/13 (**ruby 50e**, table 0505-10 R01, pos. 52)

We have verified that in some cases the articulated joint with the square end did not permit a perfect oscillation of the arm. We have modified the joint and the lower profile of the arm to improve its oscillation in any working position. The new parts are interchangeable with the previous ones.

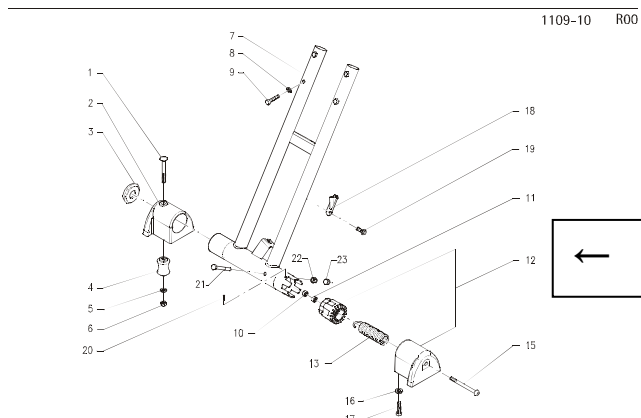
➔ Starting from serial number: 13002524 dated 03/07/13 (**baby e**, table 1109-10 R00, pos. 12)

The profile of the coupling teeth between the left support and the toothed terminal (V1009010) has been modified.

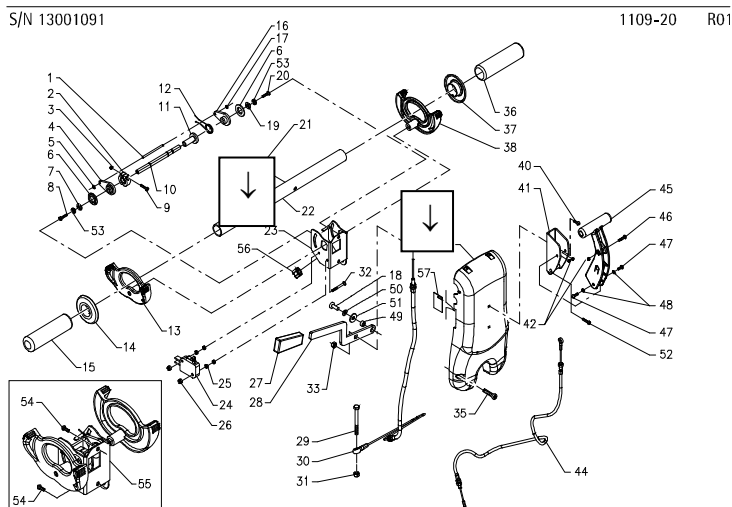
We have updated table 1109-20 R01 of **baby e**, adding the pos. 56 and 57.

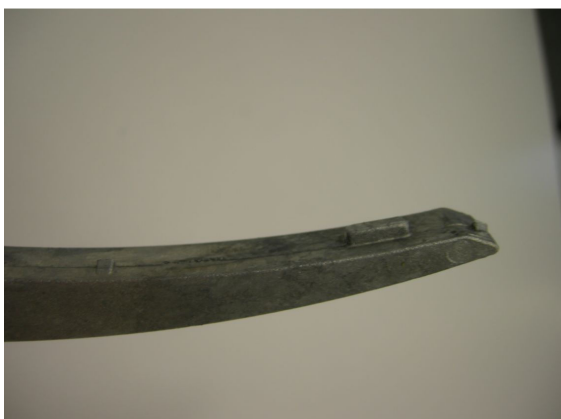
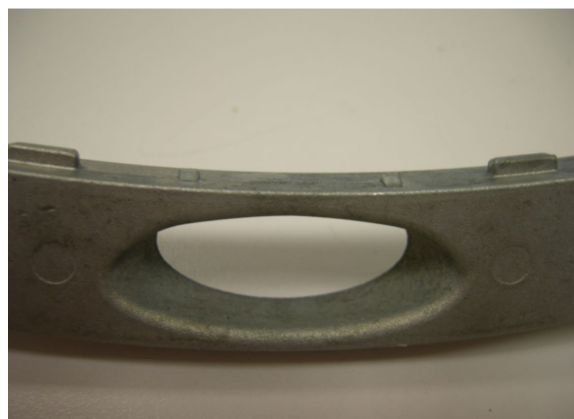
Shortly, there will be a new inner rubber holder for the squeegee on **baby e**.

It happened sometimes that the front squeegee rubber in some points was not sufficiently blocked and due to the friction with the floor it tended to slip off partially. To avoid this inconvenience, we have modified the inner rubber holder adding more gripping teeth. The new rubber holder is interchangeable with the previous one.
